Case Study 10

Human Error

Incident at E1 Jetty, 1 August 2005

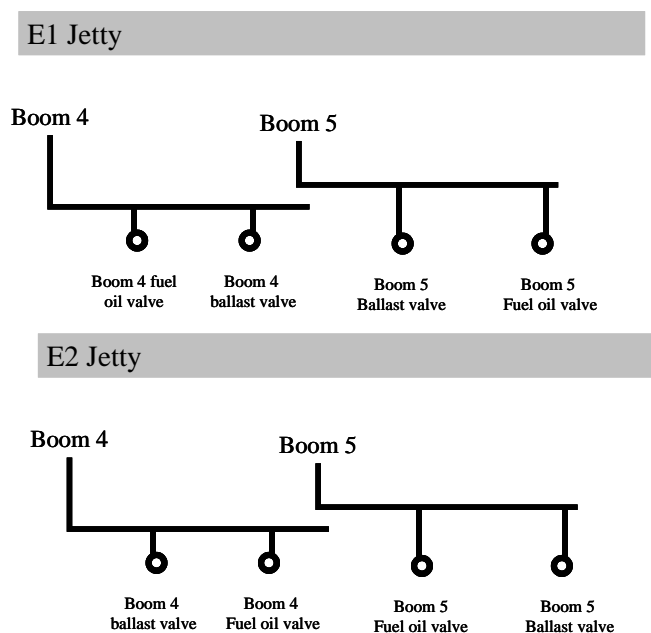
Boom and Valve Configuration

The fuel and ballast valves are identical and have no labels or colour-coding to indicate which is which, so it was not possible to visually distinguish between them. There was no written procedure for valve line-up for loading and un-loading vessels, or line-cleaning.

No information available to indicate which valve was which (e.g. colour, shape coding). There is some information available in terms of the position of the two valves in relation to each other, but this is unclear due to the different layout on the adjacent boom and on the other jetty. All the problems associated with inconsistent layout and lack of coding indicates poor ergonomic input during design.

a. Distinguish valves by

- i. Colour
- ii. Shape
- iii. Consistent layout in all locations
- iv. Other suggestions to distinguish valves
