Case Study 1

Manual Handling: Fire Water Pump Station Valves

Issue: Difficulty opening valves at Fire Water Pump Station

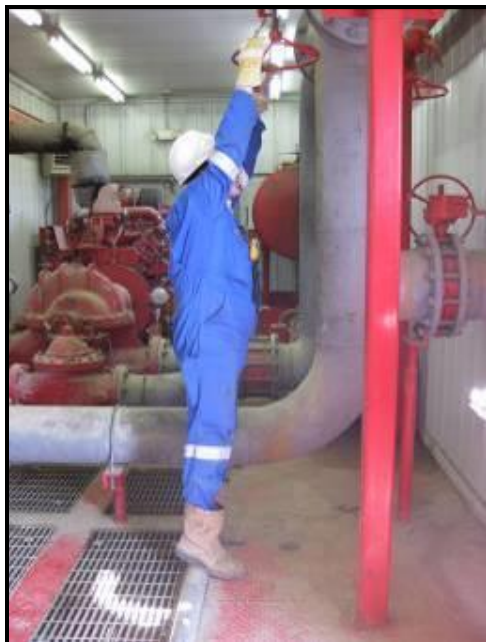
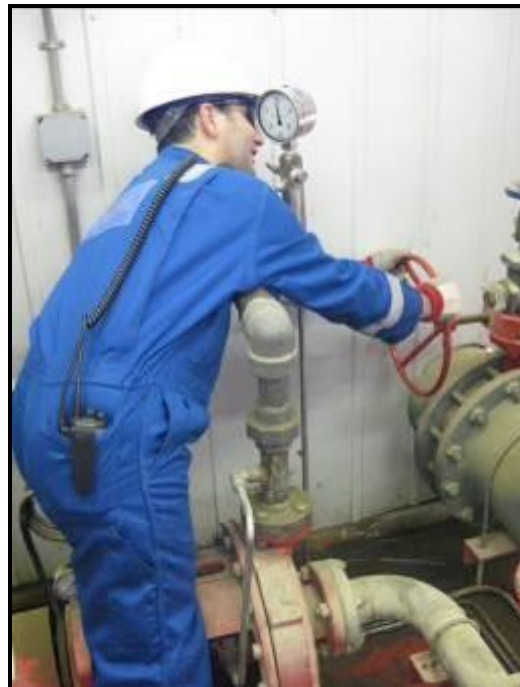
- Valves opened weekly
- Well lit environment
- Good valve maintenance programme
- Location of valves requires operator to adopt awkward postures and climb on other equipment to reach

1. Increase length of valve stem to reduce need to stretch
2. Re-orientate valve to avoid reaching across other equipment, e.g. rotate 90 degrees.
