M501: MEASUREMENT OF HAZARDOUS SUBSTANCES INCLUDING RISK ASSESSMENT

CASE STUDY 5 – HIGH ENERGY PETROLEUM

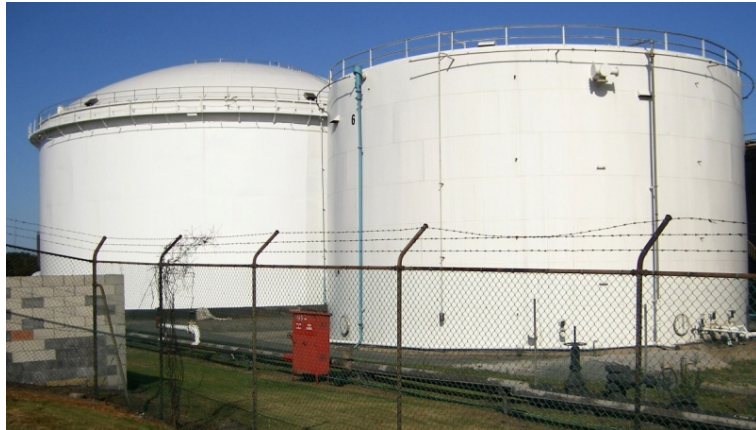
Photograph 1 – Typical Fuel Storage Tanks

Gasoline (petrol) is stored at refineries and distribution terminals in various size tanks typically 10-15 metres high and 20-30 metres in diameter (photograph 1). Periodically these tanks have to be emptied and cleaned of sludge, which accumulates on the bottom of the tank, and rusty scale which forms on the inside lining of the tank. The cleaning of tanks used for leaded product is potentially hazardous owing to the presence of flammable and toxic vapours, including lead and hydrocarbons.

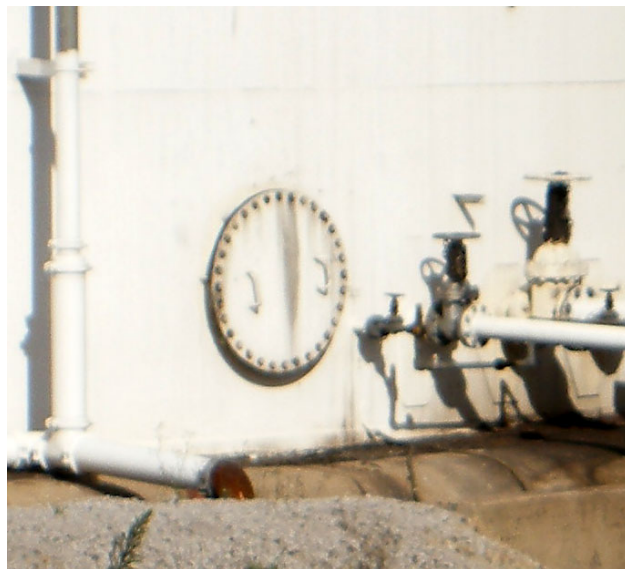
Photograph 2 – Typical Entry Manhole

This tank has two 90 cm diameter manholes (photograph 2) located diagonally opposite each other and positioned about 0.5 metres above ground level.
